May 23, 2019

**Garvin Boward Beitko  
Engineering, Inc.**  
180 Bilmar Drive  
Suite IV  
Pittsburgh, PA 15205  
Phone: (412) 922-4440  
Fax: (412) 922-3223

Subject: Geotechnical Engineering Review of Stability Analyses and Report  
Section of Amsler Ridge Road  
Economy Borough, Beaver County, Pennsylvania  
Garvin Boward Beitko File 19024

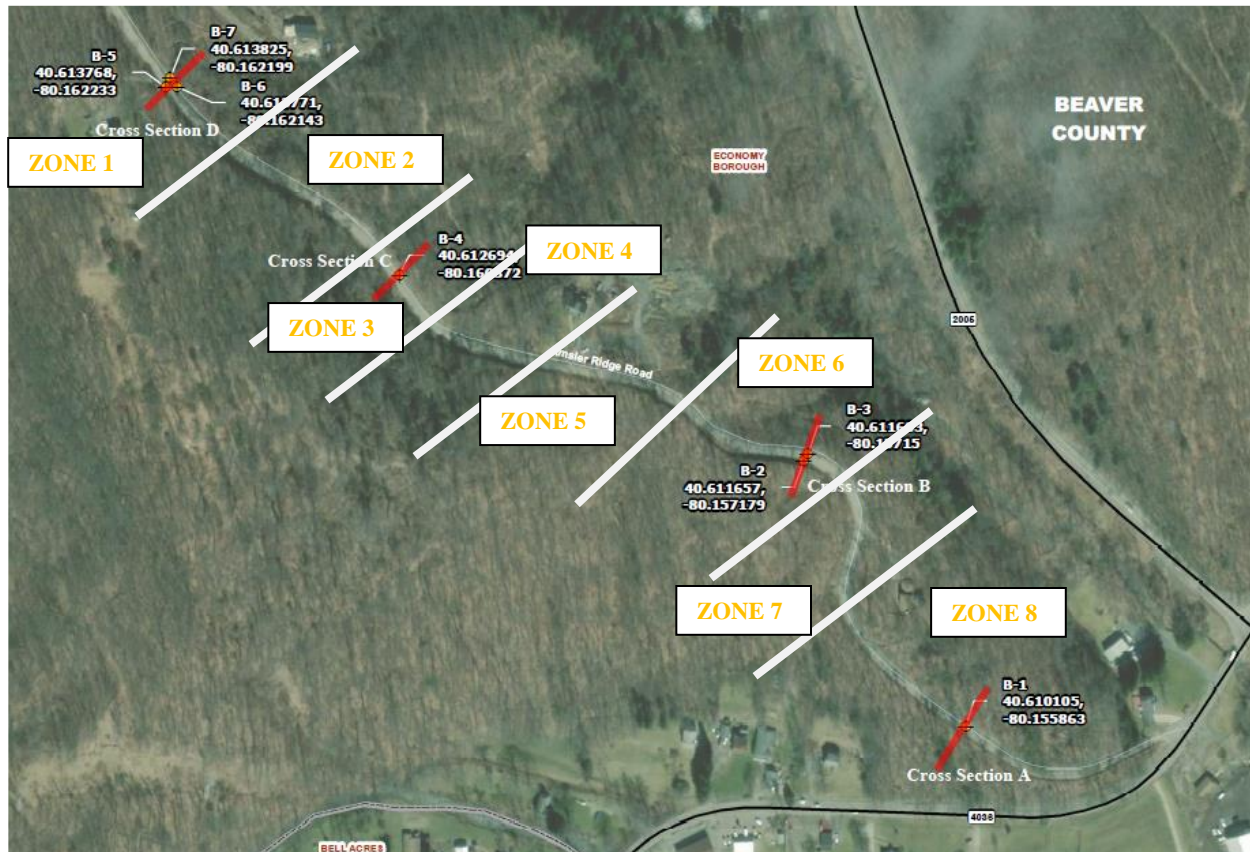
**FIGURE 1 – MARKED-UP EXCERPT FROM SSE REPORT**

As part of our review, on May 8, 2019, we visited the approximately 0.6-mile-long section of Amsler Ridge Road investigated by the SSE Report. The photos herein, taken by us on that date, are referenced via the marked-up copy of the SSE Amsler Ridge Road – Boring Locations (BL) drawing, herein included as Figure 1. We superimposed Zones 1 thru 8 on the BL to assist with site condition conditions herein discussed.

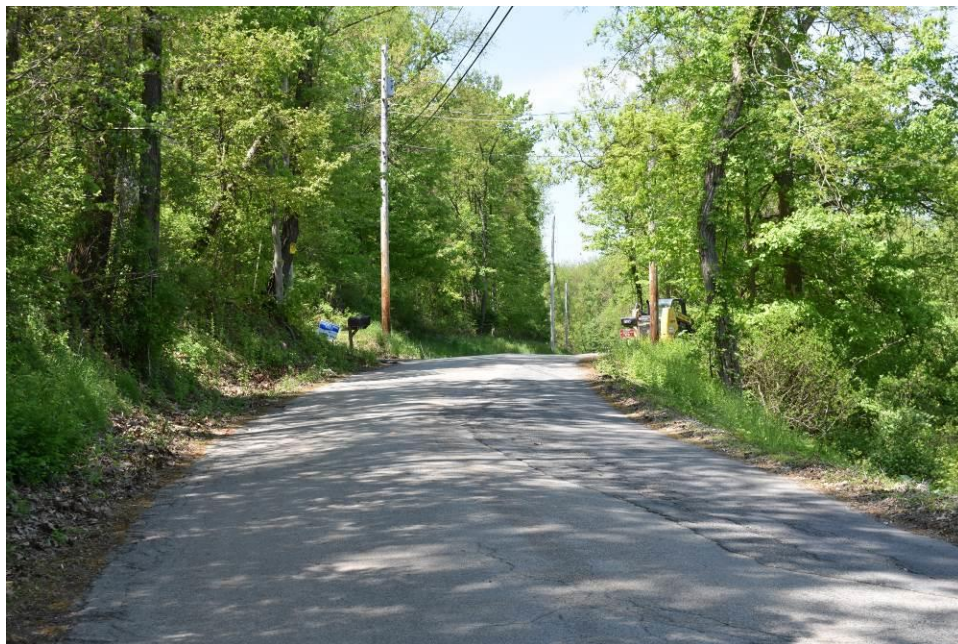
Photos 1 thru 4 show Zone 1, as indicated on the marked-up BL drawing, where SSE had Borings B-5, B-6, and B-7 drilled. This is the area where SSE recommends that the roadway low-side slope, northeast of the road, should be stabilized via a conventional soldier beam and lagging (SBL) retaining wall, as illustrated on the SSE Wall Drawings. We concur with this SSE recommendation.

**PHOTO 1 – LOOKING NORTHWEST AT ZONE 1 AREA**

1. We concur with the SSE retaining wall recommendation. However, we noted potential problematic slope stability issues southeast of the proposed wall terminus. Hence, this concern should be addressed. Possible solutions, in our opinion, entail extending the wall or, instead, providing adequate instrumentation to monitor the down-slope area southeast of the proposed retaining wall.

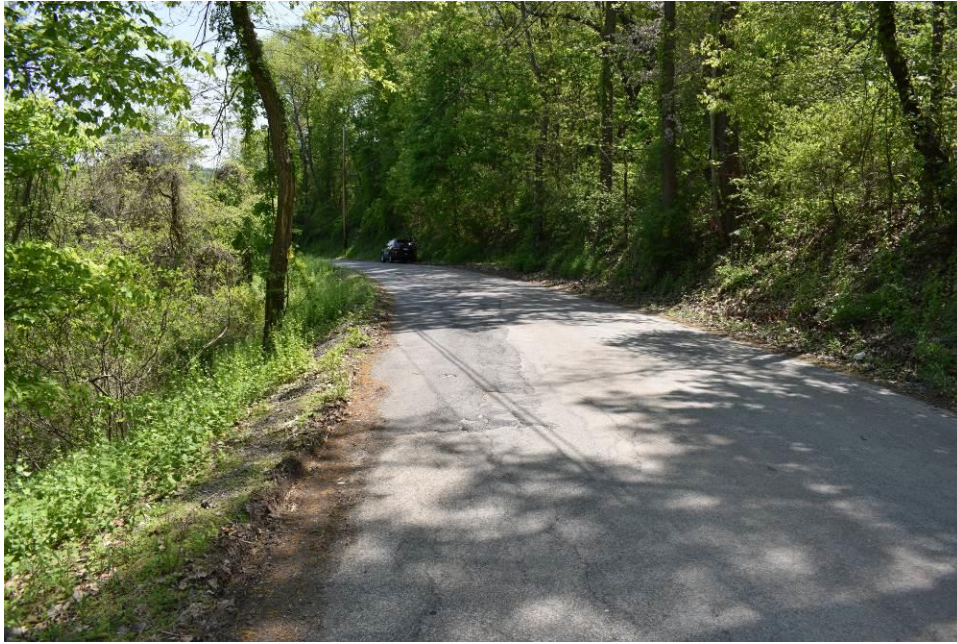
**PHOTO 2 – LOOKING SOUTHEAST AT ZONE 1 AREA (ASPHALT PATCH AT APPARENT FORMER LANDSLIDE AREA ENCROACHMENT INTO ROADWAY)**

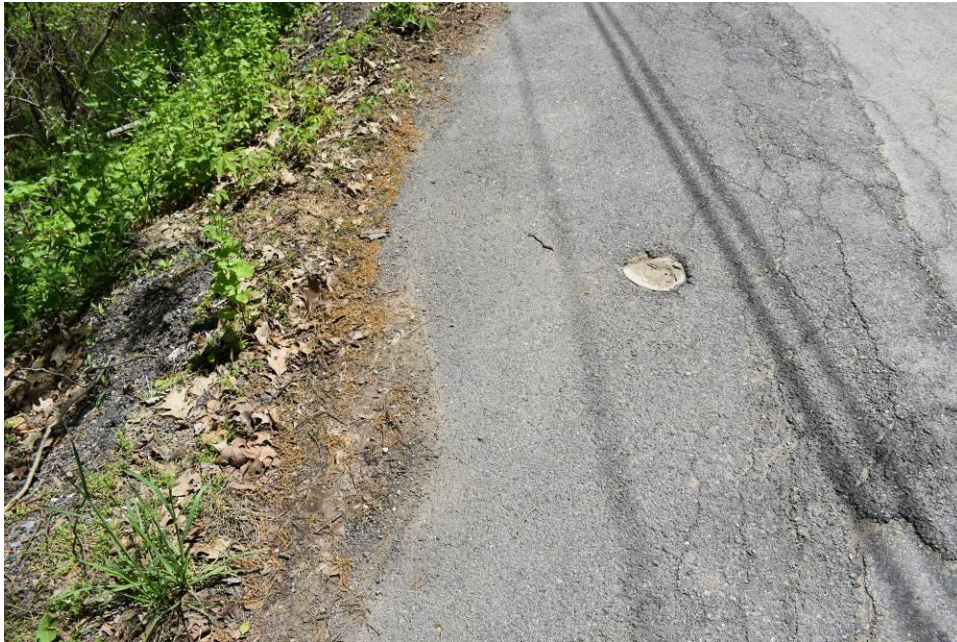
**PHOTO 3 – CLOSE-UP OF AREA ON PHOTO 1 (APPARENT SSE BORING LOCATION)**

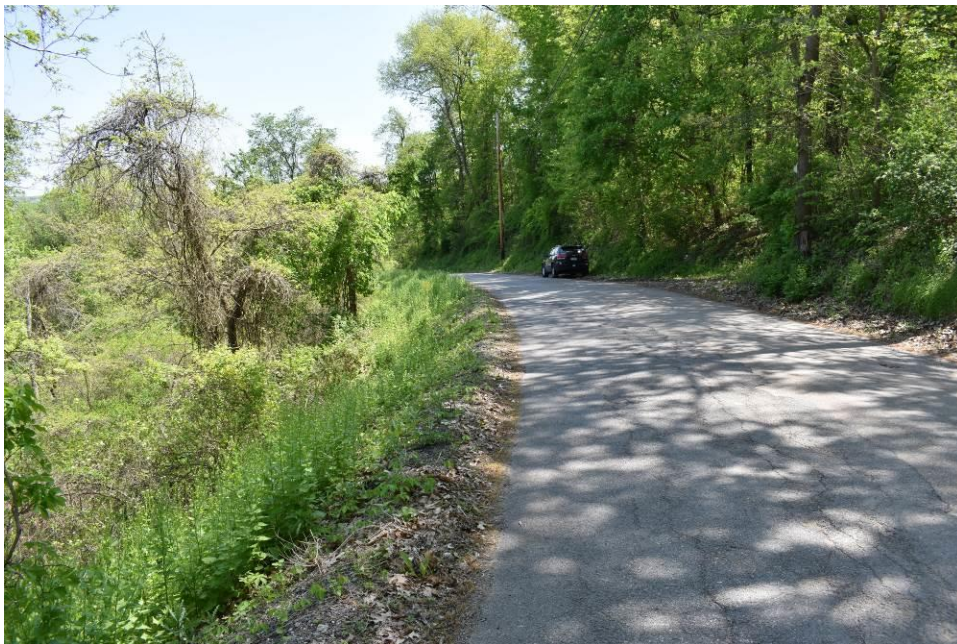
Photos 5, 6, and 7 show Zone 2, where the roadway is patched nearby the top of the slope along the low-side of the roadway.

**PHOTO 5 – LOOKING SOUTHEAST AT ZONE 2 AREA**

The distressed and cracked asphalt pavement at the Zone 2 area appears to be related to the same hillside instability discussed for the Zone 1 area. It is unclear to us whether the SSE-recommended SBL retaining

wall will extend to this area. In our opinion, it would be prudent to include this roadway zone within the stabilization plan.

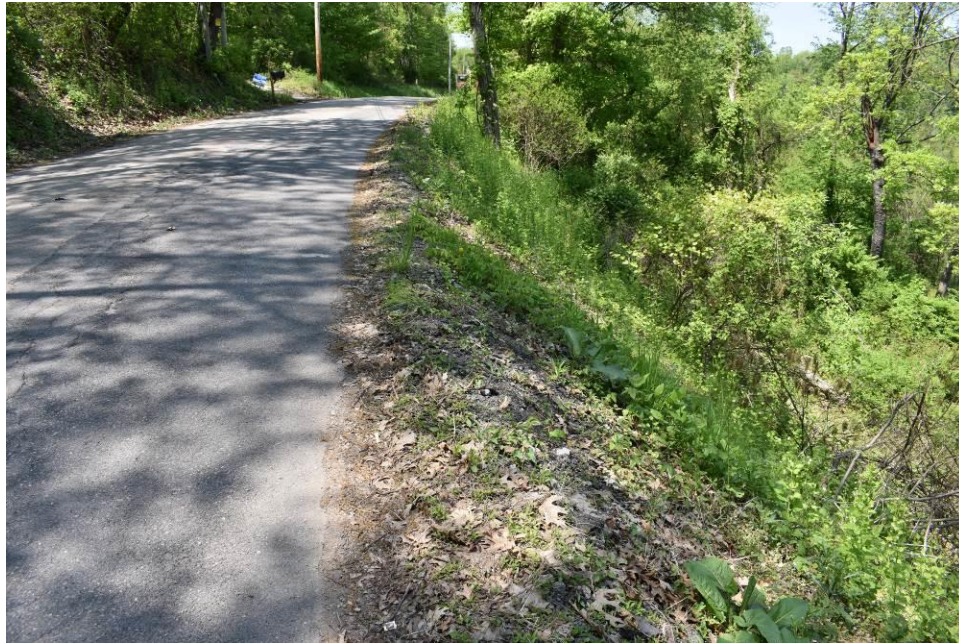
**PHOTO 6 – LOOKING NORTHWEST AT ZONE 2 AREA**

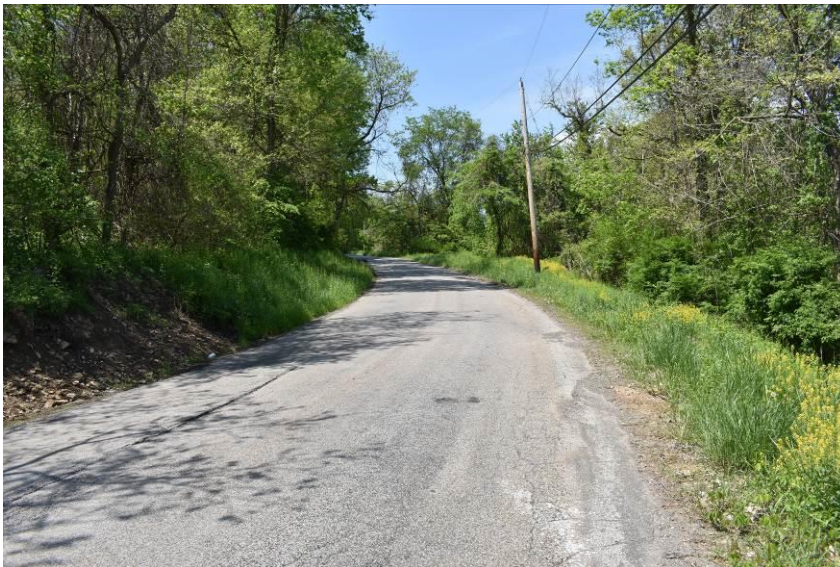
Zone 3, shown on Photos 8 and 9, exhibits pavement cracks on the low-side of Amsler Ridge Road, as well. However, based on the adjacent hillside condition, we suspect that these pavement distresses are related to pavement subgrade failure. Thus, we are concerned that the roadway pavement subgrade, likely including the subbase, may be inadequate. Regardless, as of our visit, this zone does not appear to visually exhibit obvious slope instability.

**PHOTO 8 – LOOKING  
NORTHWEST AT ZONE 3**

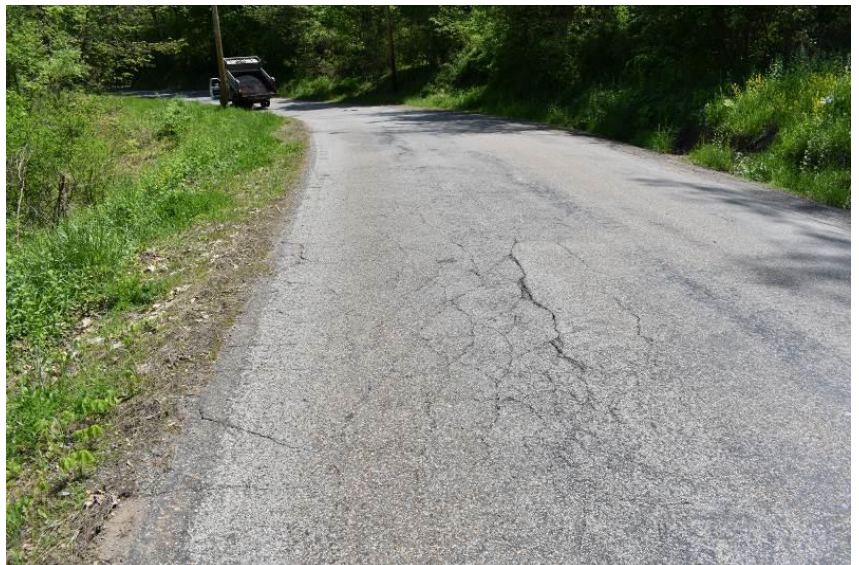
**PHOTO 9 – LOOKING SOUTHEAST  
AT ZONE 3 AREA**

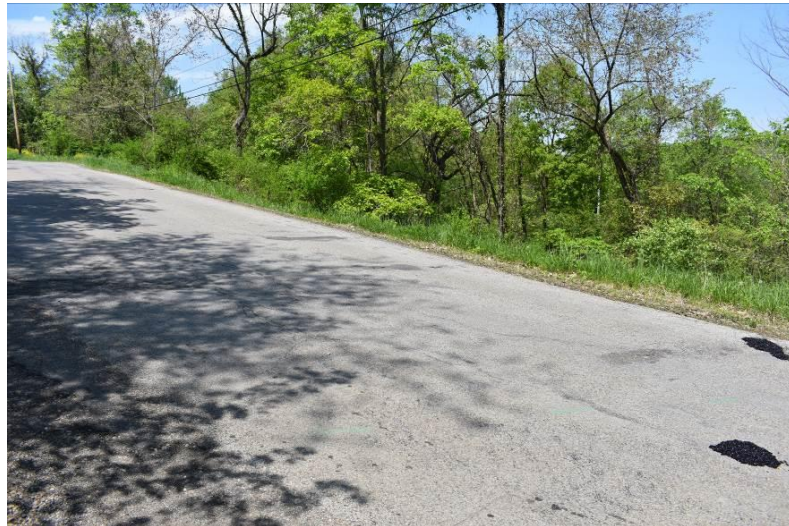
Zone 4, shown on Photos 10 thru 16, displays cracked asphalt pavement at the roadway low side. Below, and northeast of Amsler Ridge Road, we found an apparent aged cut area. Its purpose is unclear.

**PHOTO 10 – LOOKING  
NORTH AT ZONE 4 AREA**

Although at this juncture, we discerned no common signs of slope instability at this area, such a cut area, which reduces forces that tend to resist slope movements/failure, possesses the potential to eventually result in problematic slope conditions. Hence, it would be prudent to monitor this hillside area with respect to movements, as required to understand its status and react to it should the monitoring system reveal apparent problematic performance.

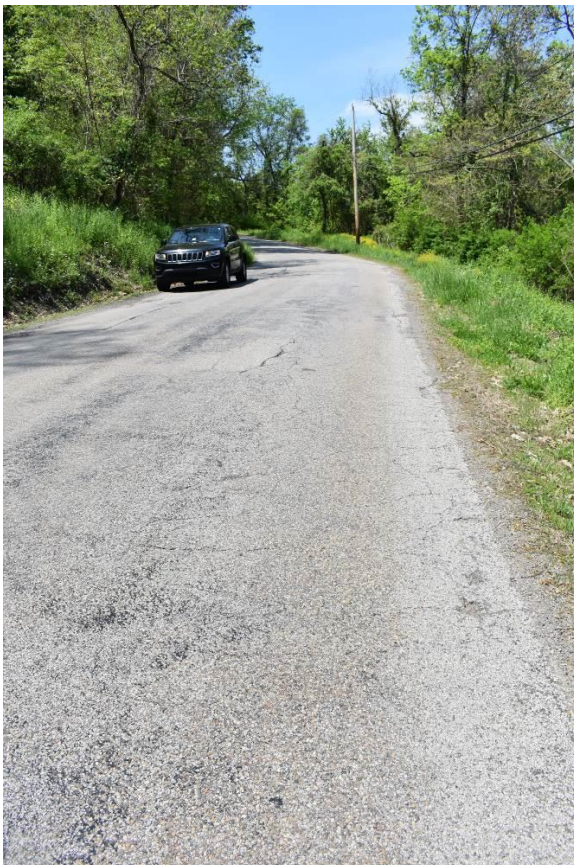
**PHOTO 11 – LOOKING NORTHWEST AT  
ZONE 4**

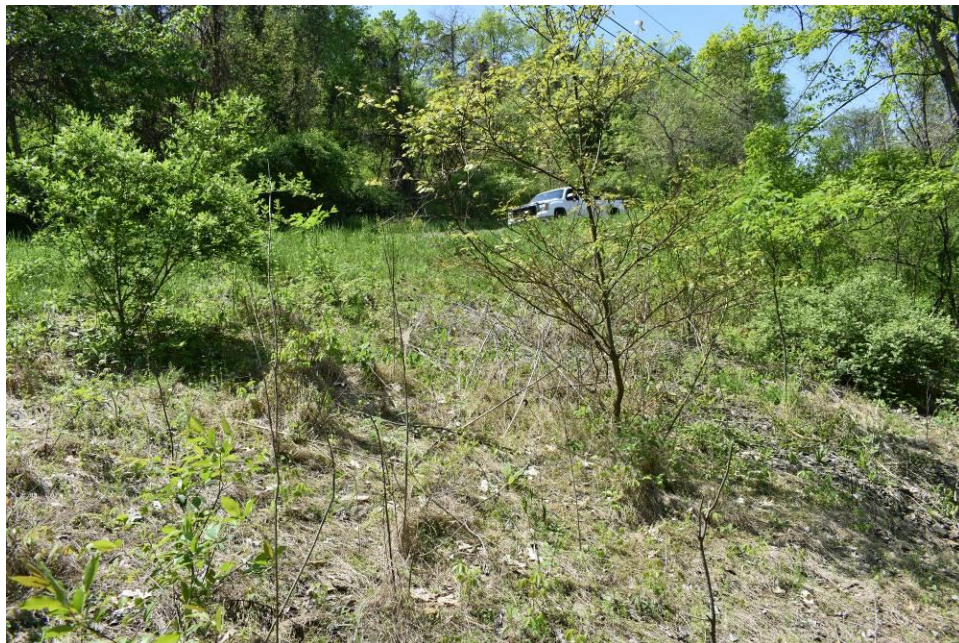
**PHOTO 13 – LOOKING SOUTH TOWARD ROADWAY AT ZONE 4**

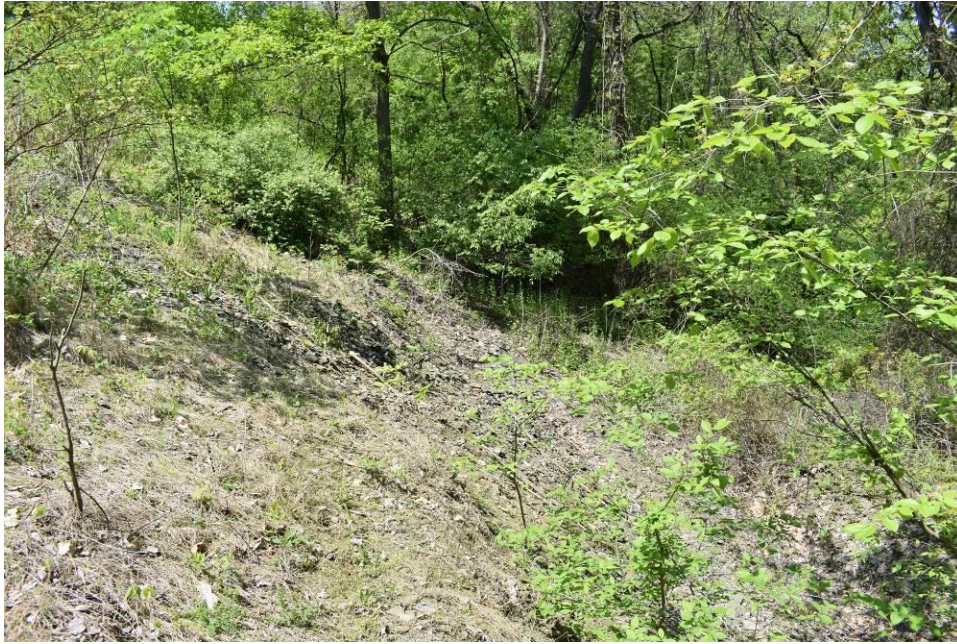
**PHOTO 14 – AREA RIGHT OF PHOTO 13 (OLD CUT AREA ON HILLSIDE)**

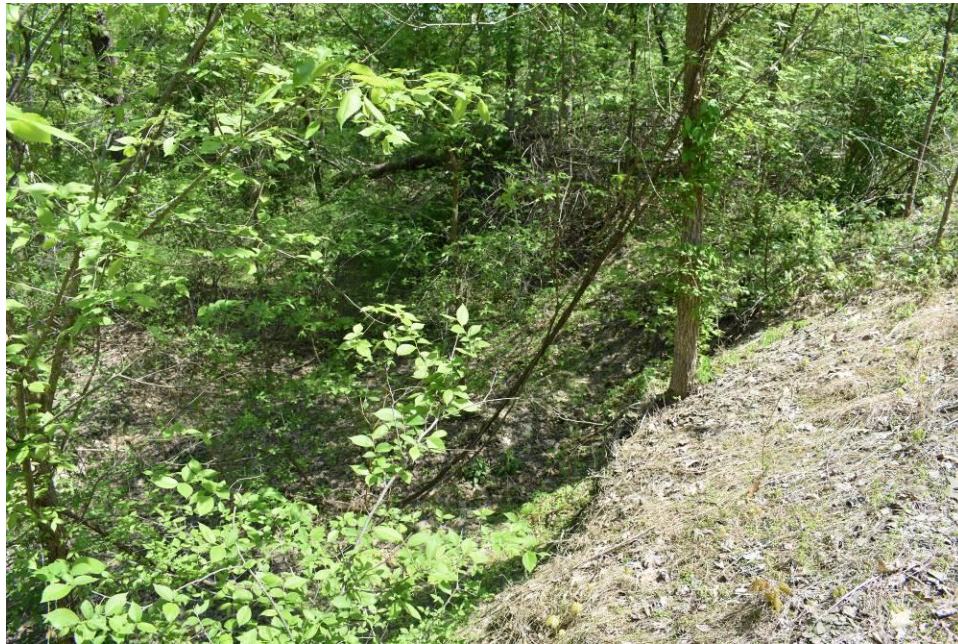
**PHOTO 16 – AREA RIGHT OF PHOTO 15  
(OLD CUT AREA ON HILLSIDE BELOW AMSLER RIDGE ROAD)**

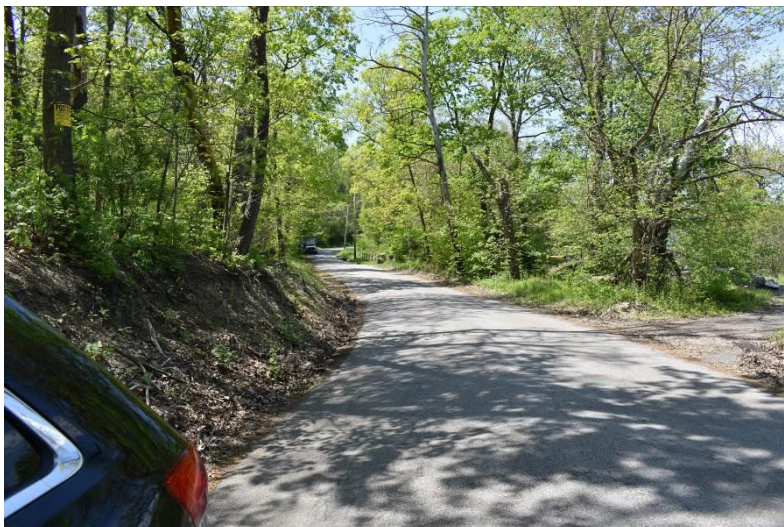
Photos 17 thru 22 show Zone 5. A large and apparently non-engineered fill embankment is situated on the hillside below and northeast of Amsler Ridge Road at this zone. The fill embankment appears to include substantial organics, which are inherently unstable. The fill generally looks to have been end-dumped without proper subgrade preparations, drainage, bonding, placement, differentiation, and compaction. We did not attempt to comprehensively evaluate the fill embankment. Although we observed no obvious signs that the embankment has yet detrimentally impacted Amsler Ridge Road, such a condition – if it should move or fail – possesses the potential to result in distresses to the roadway. Thus, it would be prudent, in our professional opinion, to monitor the hillside on the low side of Amsler Ridge Road at this zone, as it may be only marginally stable in its current configuration.

**PHOTO 17 – LOOKING  
NORTHWEST AT ZONE 5  
AREA**

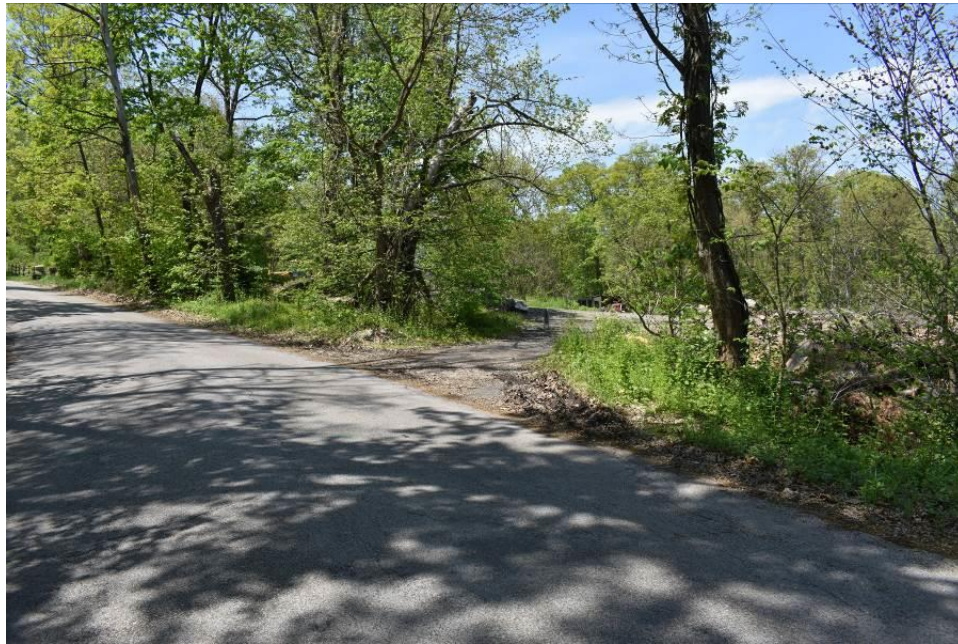
**PHOTO 18 – AREA RIGHT OF PHOTO 17  
(ENTRY ROAD TO FILL EMBANKMENT AREA)**

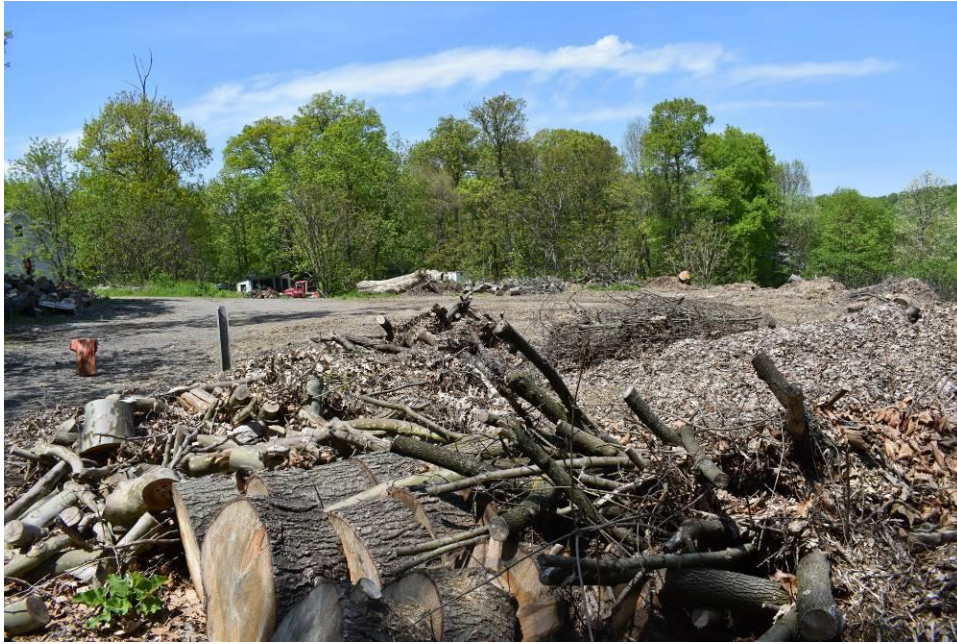
**PHOTO 20 – CLOSE-UP OF AREA ON PHOTO 19  
(FILL EMBANKMENT AREA)**

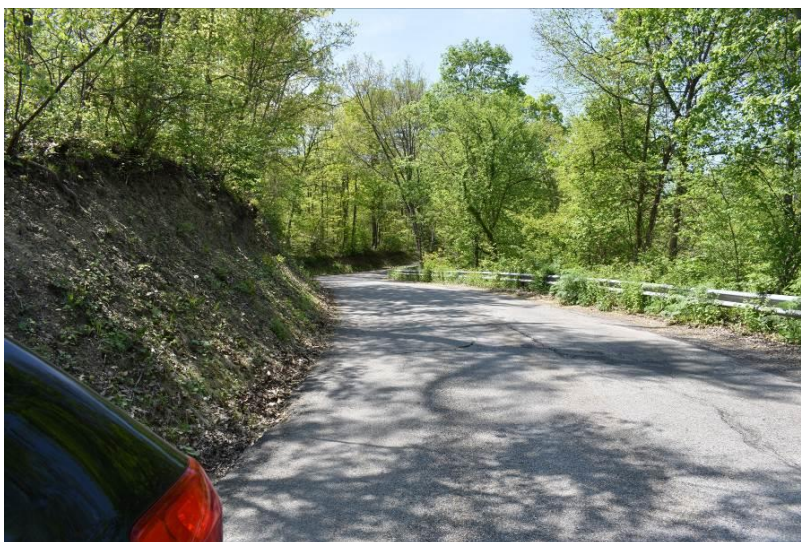
**PHOTO 23 – ZONE 6 AREA**

Photos 23, 24, and 25 generally depict Zones 6, 7, and 8. We observed some pavement distresses. However, they appeared to be related to pavement subgrade failure and/or inadequate pavement structure section thickness. Although soil creep – a long-term condition wherein the hillside upper soil mantle creeps down-slope on a seasonal basis due to freeze-thaw effects common to a region at this latitude – was observed, no obvious landslide or unstable slope conditions were seen. Soil creep, which occurs on most hillsides to varying degrees in southwest Pennsylvania, is not necessarily a sign of instability. Typically, the affected upper soil mantle “heals” and regains its shear strength during drier seasons.

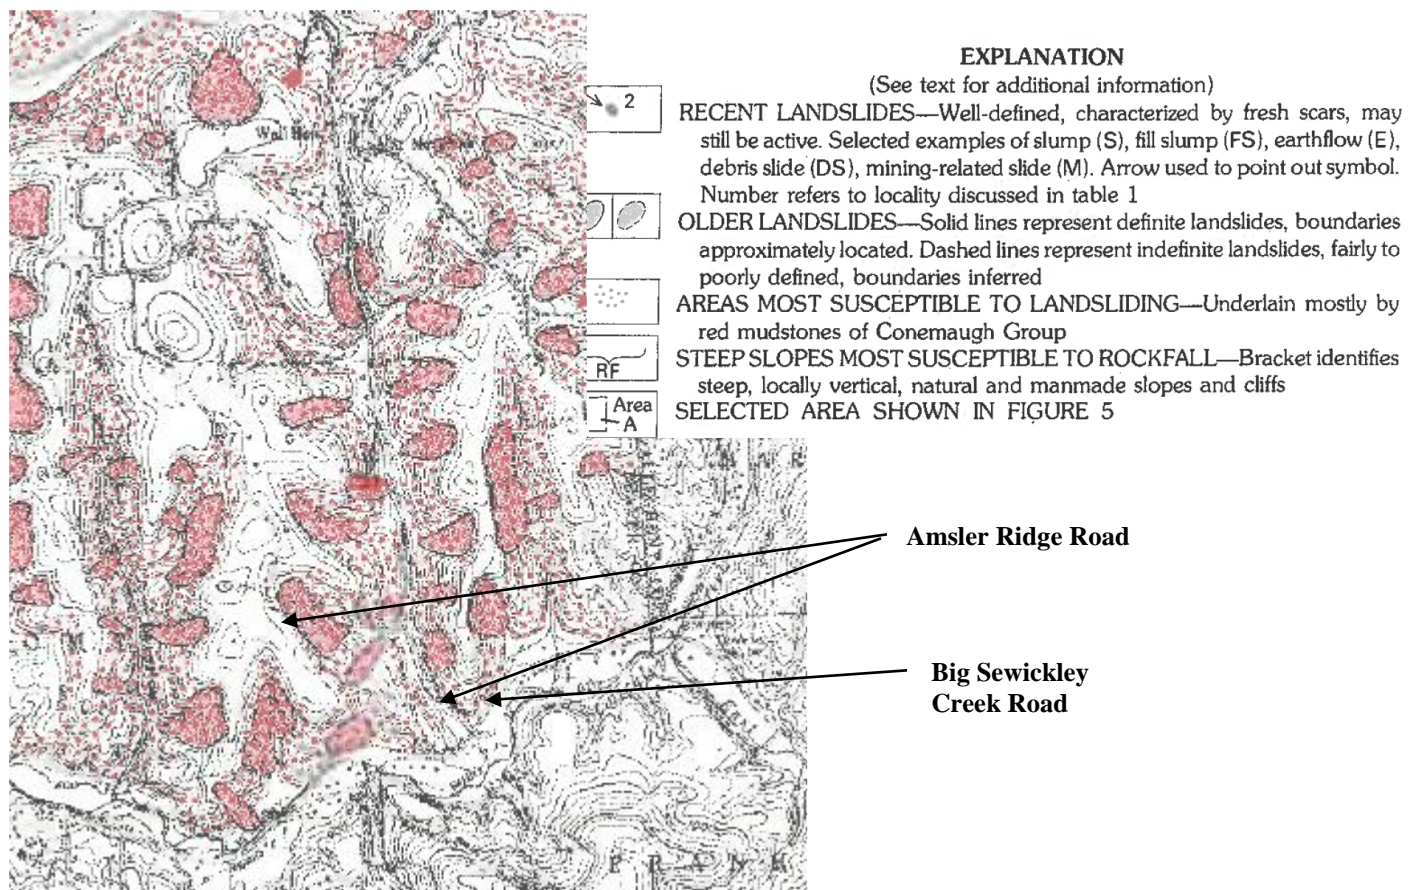
**FIGURE 2 – EXCERPT FROM AFOREMENTIONED REFERENCE 2**

area; primarily areas underlain by claystone, mudstone and shale associated with other rock types. Rock weathers rapidly on exposure forming clayey soil highly susceptible to sliding.” The second reference, an excerpt of which is provided herein as Figure 2, shows the section of the roadway situated in an area deemed to be “Areas Most Susceptible To Landsliding,” therein defined as areas “Underlain mostly by red mudstones of Conemaugh Group.” Reference 2 also shows significant “Older Landslides” areas along the northeastern low-side of the roadway. This reference describes these areas via, “Solid lines represent definite landslides, boundaries approximately located. Dashed lines represent indefinite landslides, fairly to poorly defined, boundaries inferred.” The “Older Landslides” area appears to be generally situated in Zones 1 thru 5.
